# Assessment of non-household toilet facilities in the Kathmandu Valley, Nepal

*In this study non-household toilet facilities in the Kathmandu Valley have been assessed.*

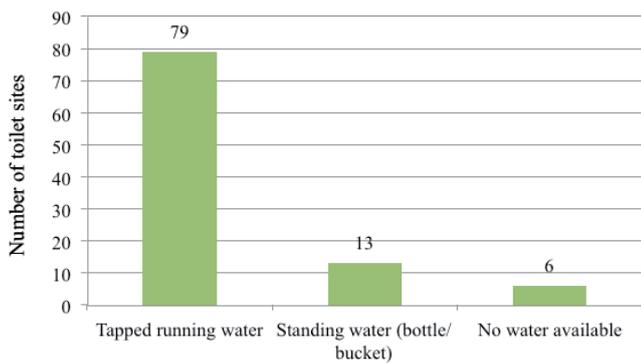
**Figure 1: Availability of water in the toilet facilities**

81% of the toilet facilities (n=79) had tapped running water available (inside toilet units) for backside washing and flushing purposes, as well as hand washing purposes. Another 14% (n=13) of the facilities assessed had no running water but rather water standing in buckets/mineral water bottles. No water was present in the toilet premises in six percent (n=6) of the toilet facilities assessed. Figure 1 shows the availability of water in the toilet facilities for the aforementioned purposes. Though the facilities were designed for running water uses (e.g. flushing toilet units, hand-washing basins etc.), the functionality of running water was absent largely due to unmaintained water supply.

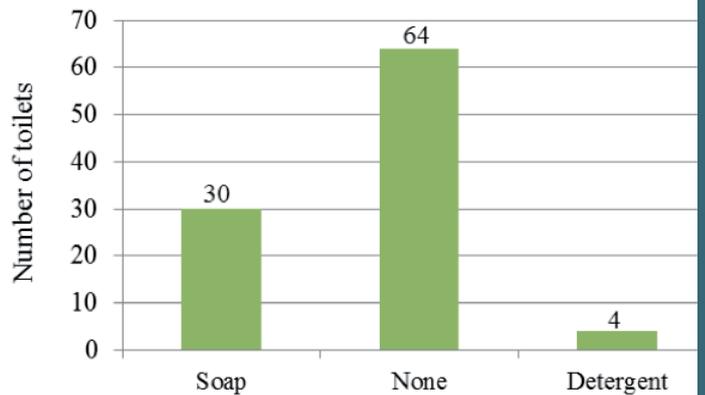
**Figure 2: Provision of hand washing (hand disinfection) facility in the toilet areas**

The presence of soap or detergent at the toilet facilities for hand washing after toilet use was assessed. Nearly 82% of the toilet areas (n=80) had wash basins for hand-washing purpose with six of them being non-functional in terms of water availability. Nearly two thirds of the toilet areas were found to be devoid of any soap or detergent for hand disinfection (Figure 2). The condition of wash basins observed is shown in Figure 3.

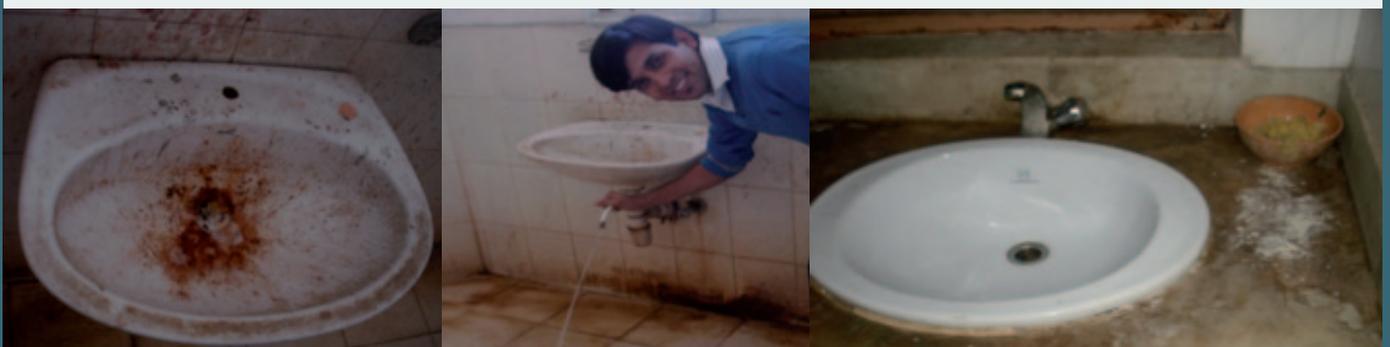
**Figure 3: Pictures showing the conditions of wash basins at the toilets**

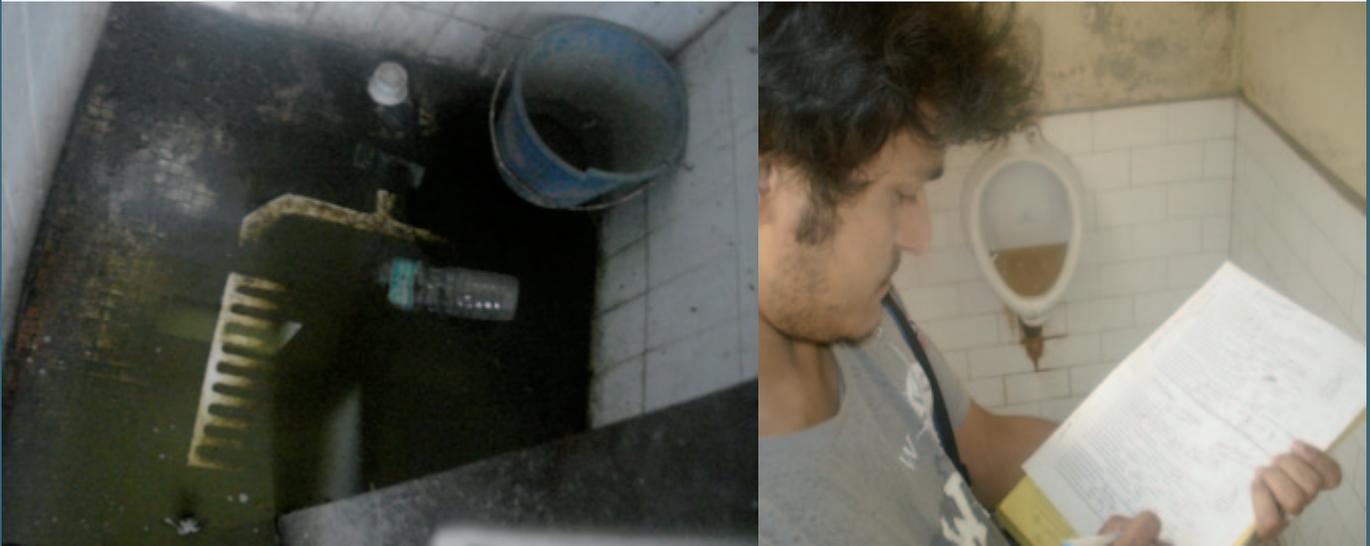
**Figure 4: A typical public toilet scene in Kathmandu (left) and an assessment of the condition (right)**
