Aquifer Recharge by Treated Wastewaters: Korba case study (Tunisia)

This paper describes the evolution of groundwater quality after recharge with treated wastewaters.

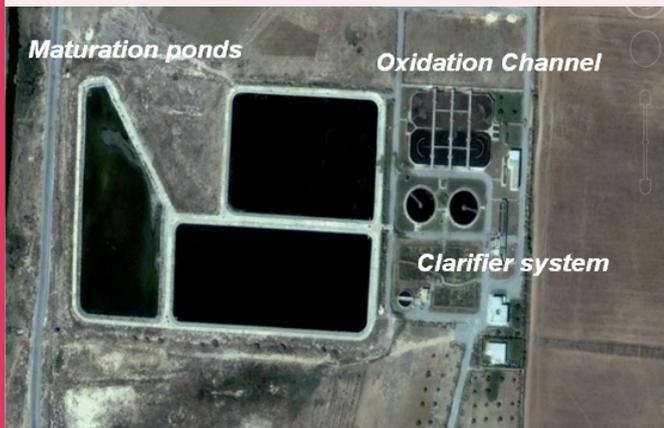
Figure 1. Korba wastewater treatment plant (© 2009 Google)

Reclaimed water used to feed the project is provided by the plant close to the infiltration basins which has begun to work in July 2002. This treatment plant is a low-load activated sludge treatment plant combined with finishing lagoons (Figure 1). It is dimensioned for 7500 m³ of wastewater per day and actually receives about 5000 m³ per day. It can provide 1500 m³/day to the recharge site.

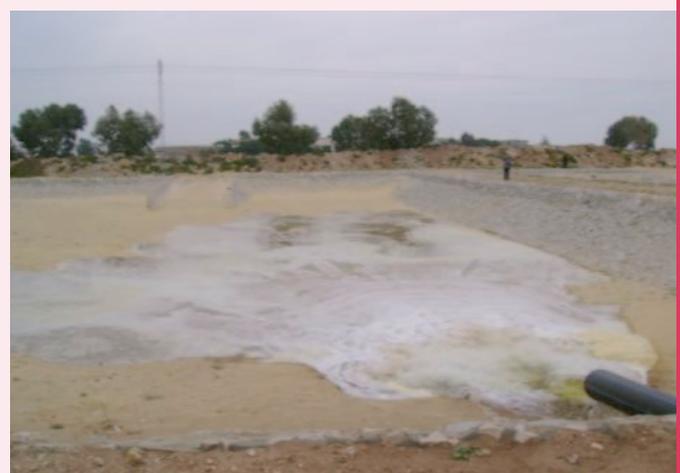
Figure 3. Filling one of the recharge ponds with TWW in Korba

1. TWW collecting reservoir: 300 m³
2. Infiltration capacity 0.5m/day
3. Three infiltration basins 1500 m² each (Figure 3).
4. Capacity of the infiltration basins: up to 1500 m³/day
5. Estimated annual recharge: 0.5 million m³/year
6. Pipe diameter for basins feeding is 400 mm
